Home Inspection Report

000 portland plc., lititz, PA 17543

Inspection Date:

Saturday March 28, 2015

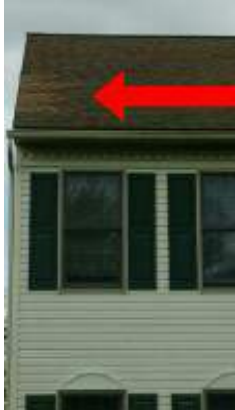
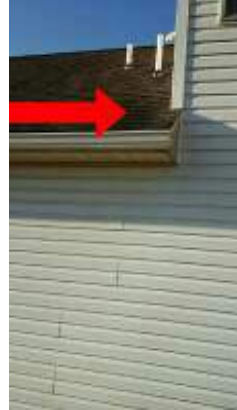
Roof was repaired, looks to be professionally done.

Signs of mildew at rear lower garage roof below vents

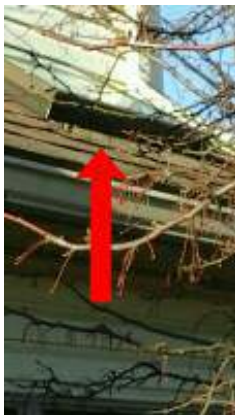
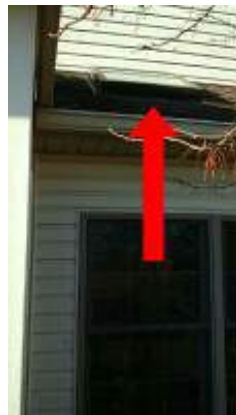
Comments Mildew present

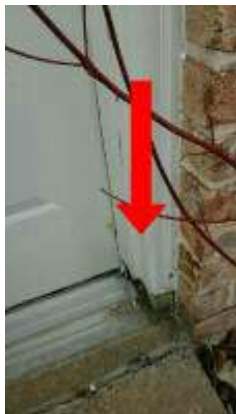
Comments Some rotted trim boards recommend repair/replacing damaged sections

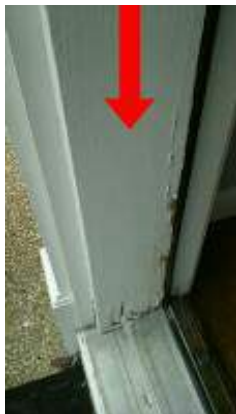
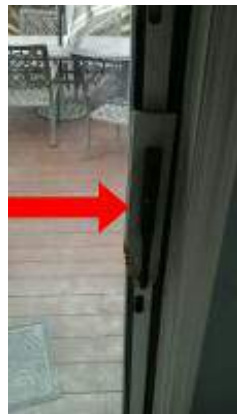
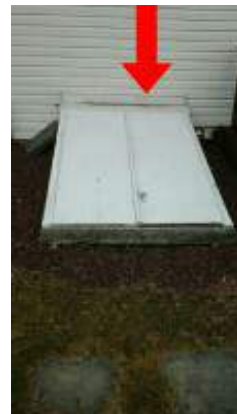
Comments Rear sliding glass door rotted/damaged, recommend repair/replacing
Recommend caulking ear cellar door
Entry door rotted/damaged, recommend repair/replacing

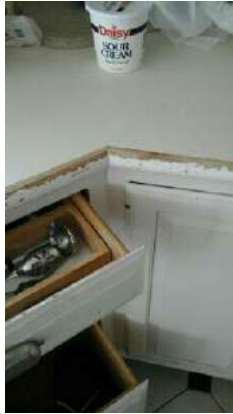
Comments Counter top has normal wear.
