Home Inspection Report

Main Street USA

Inspection Date:

Sunday January 13, 2019

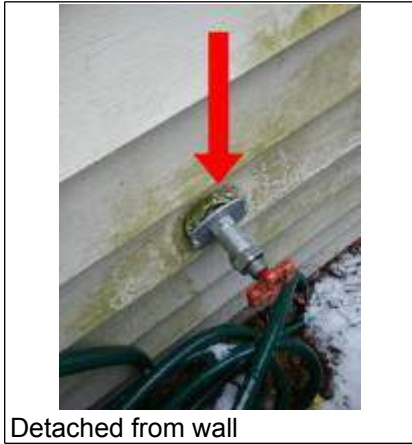
Comments Hose bib rear of house detached from wall see attached photo recommend repair

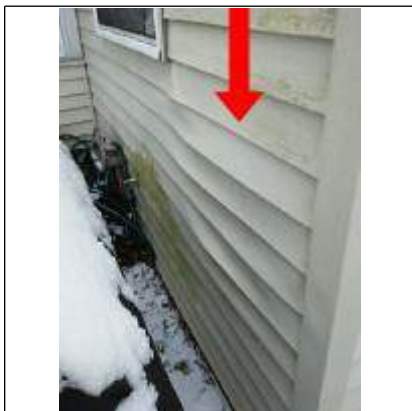
Comments Damaged siding rear of house appears to be damaged from heat from Grill place to close see attached photo recommend repair

Appears to be melted from Grill

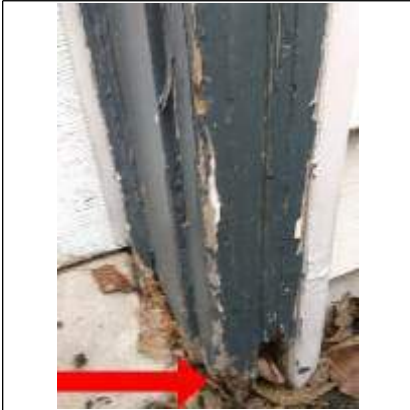
Comments Brick molding garage door damaged see attached photo recommend repair

Brick molding garage door damaged

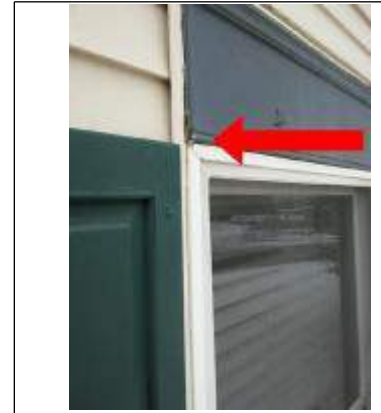
Comments Some areas where caulk is missing recommend repair see attached photos

Missing damage caulk

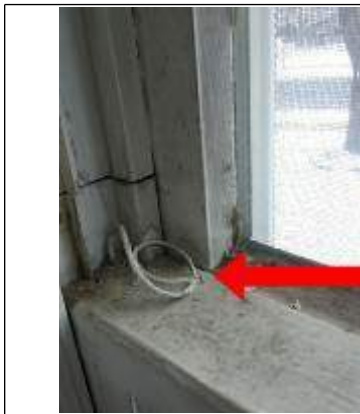
Window balance broken will not stay up living room left

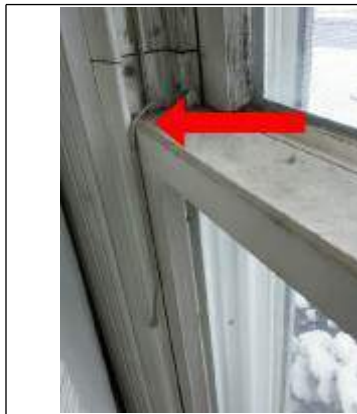
Window balance broken living room right

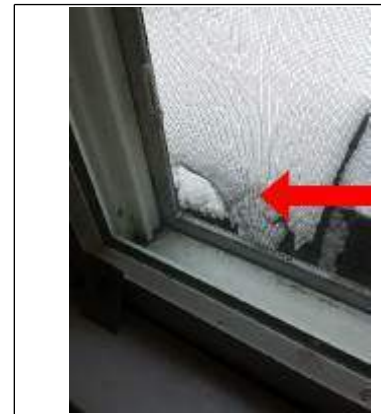
Kitchen window screen torn

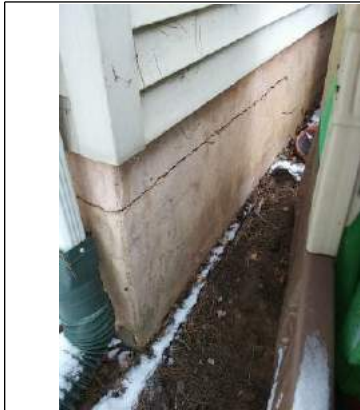
Comments West wall and southwest corner horizontal crack and step crack recommend repair and monitoring see attached photos

Horizontal step crack southwest corner

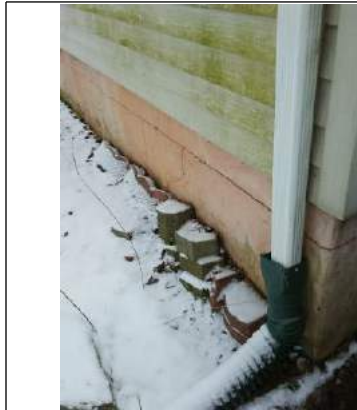
Horizontal crack West

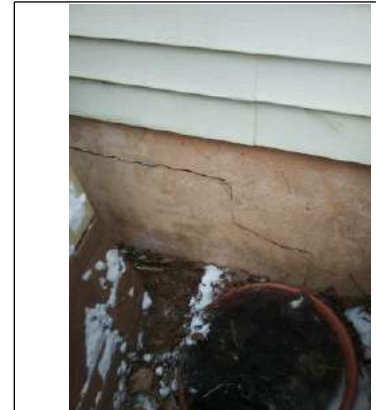
Step crack southwest corner

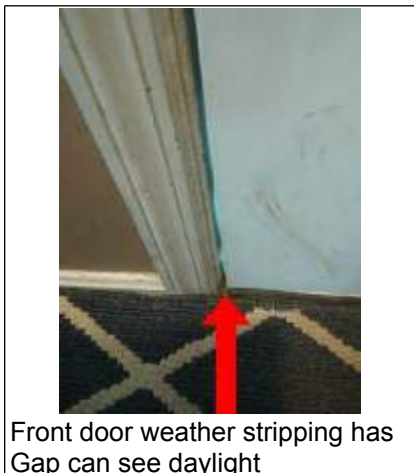
Comments Front door weather stripping has a gap see attached photo recommend replacement

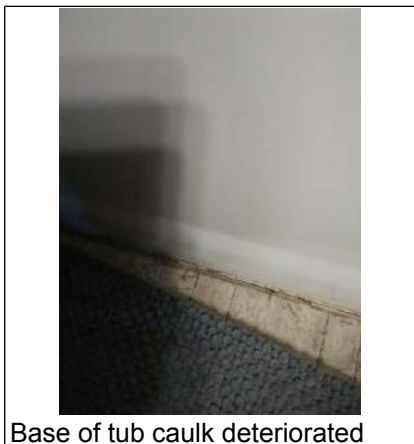
Comments Base of tub caulk deteriorated recommend repair see attached photo

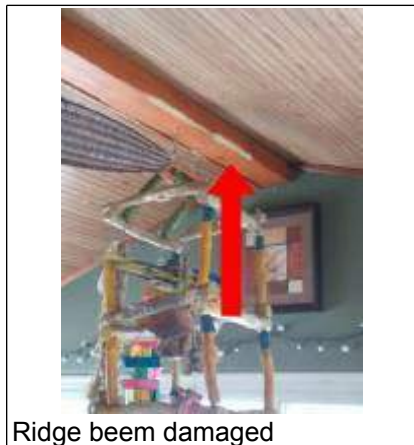
Comments Several Windows locks do not engage recommend repair.
Ceiling ridge beam damaged see attached photo recommend repair

Ridge beam damaged

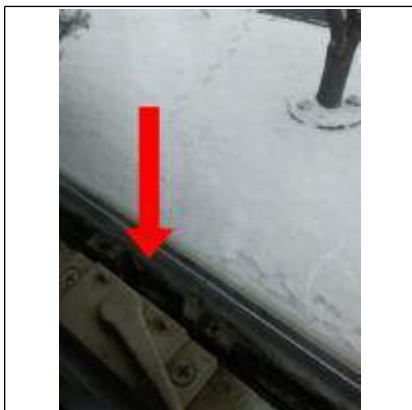
Comments Window lock mechanism is broken recommend repair see attached photo

Broken lock mechanism

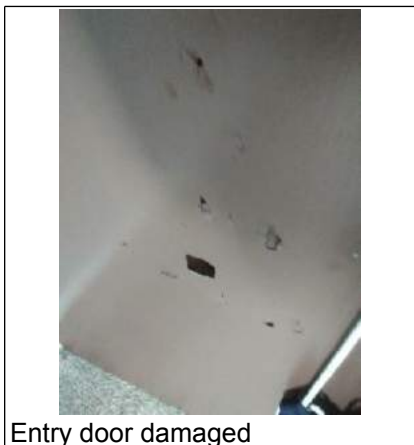
Comments Entry door damaged inside see attached photo recommend repair

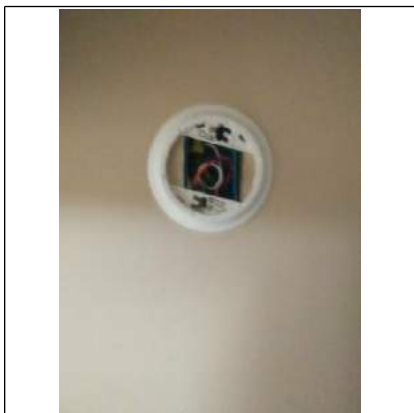
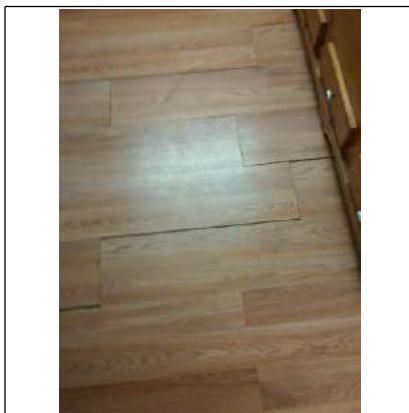
Comments Flooring damaged see attached photo recommend repair

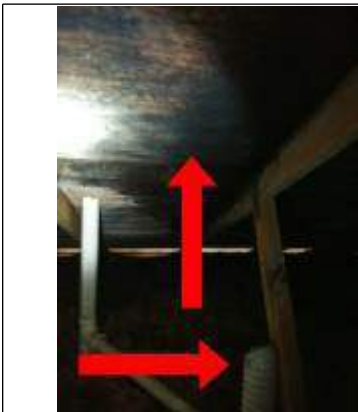
Comments Decking throughout has signs of mold like substance due to venting not being extended to soffit.
Decking overlapped at joints due to lack of expansion Clips see attached photos recommend repair.

Interior west side of Home mold like substance on roof decking also vent duct work not extended to the soffit causing condensation to fall on interior insulation

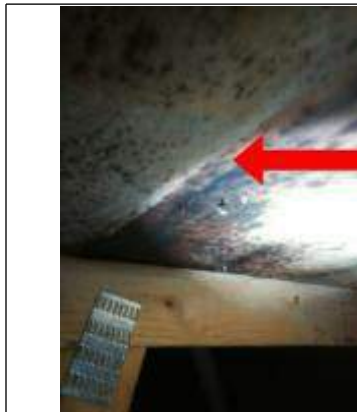
Decking overlapped due to lack of expansion clips

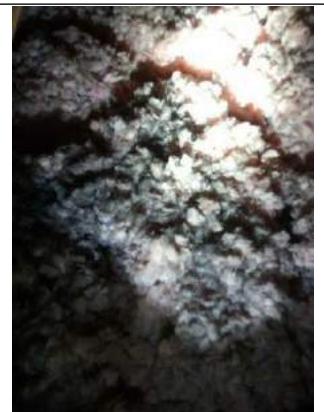
Insulation wet due to condensation falling from interior of decking down source vent not exhausted properly

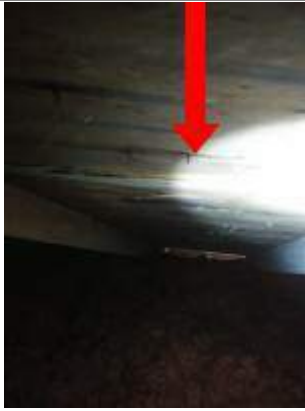
Several areas of roof decking bound up and overlapping

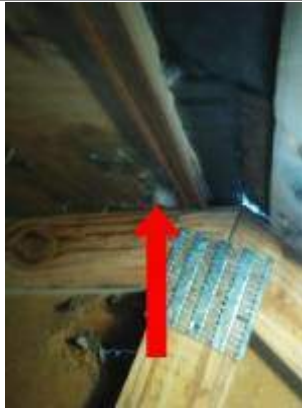
East at Ridge water entry point

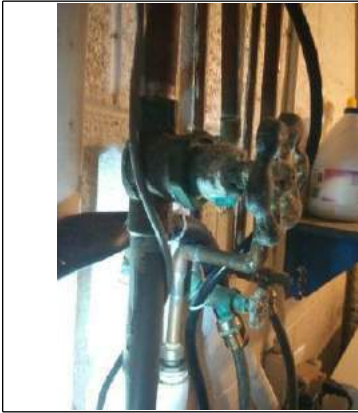
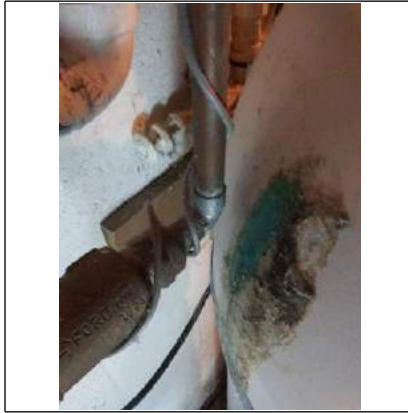
Comments Impact shut off valve at impact nut leaking on water softener see attached photos recommend repair

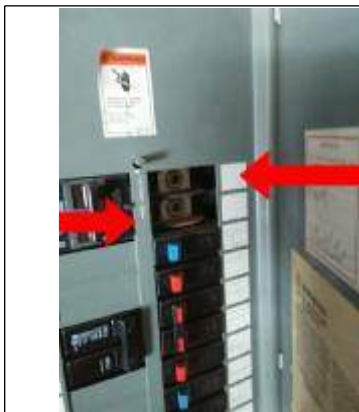
Comments Missing Knockouts potential safety hazard see attached photo recommend repair.
Cut expose wiring behind family room in closet at ceiling see attached photo recommend repair

Missing knockouts

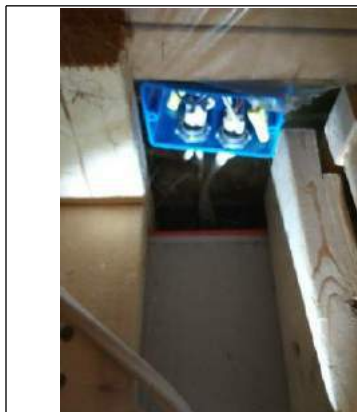
Open junction box in closet behind family room recommend repair see attached photo

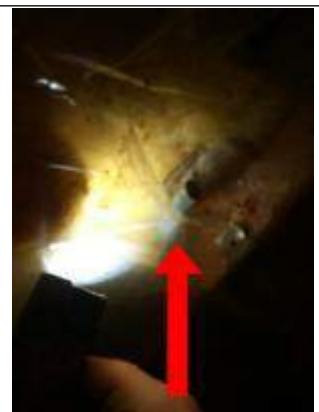
Cut exposed wiring in closet at basement behind family room recommend further evaluation and repair
