Home Inspection Report

Main Street USA

Inspection Date:

Sunday January 13, 2019

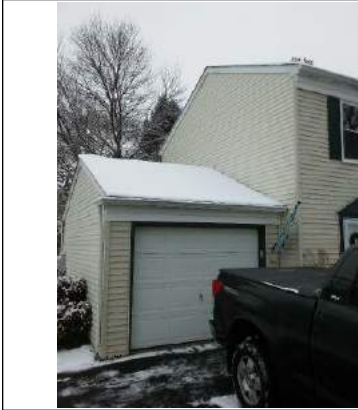
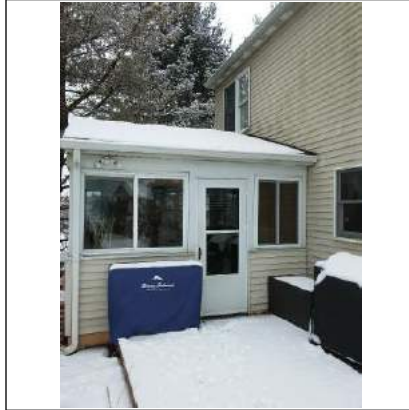
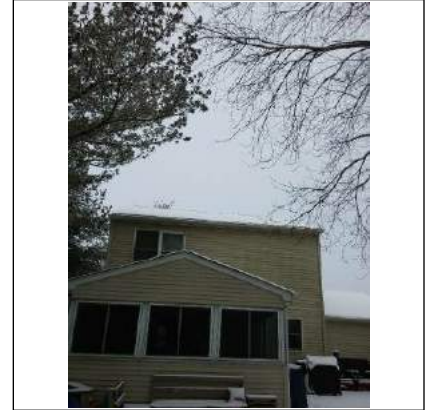
Comments Exterior inspection of roof Limited due to snow covered no signs of dips or sagging or structural defects. will inspect interior roof through scuttlehole hatch truss space interior as well see interior section for these details
